EMERGING TECHNOLOGIES

Infrared Inspection

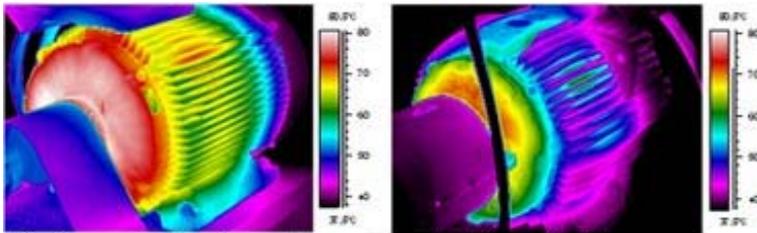
When comparing these two motors, the thermal patterns are similar, but the motor on the left has a markedly higher overall temperature. *Image courtesy of the Academy of Infrared Thermography*

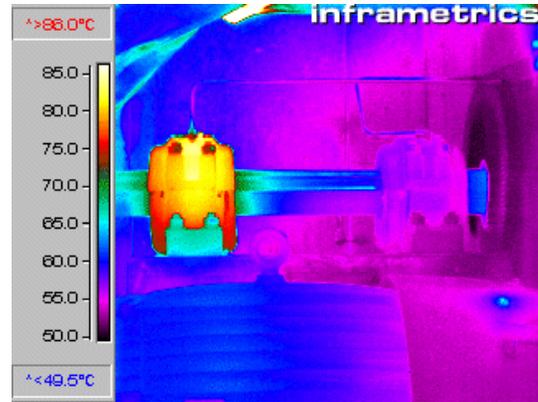
Two bearings under the same load conditions. One bearing is significantly warmer (~30 degrees Celsius) than the other. *Image Courtesy of Snell and Inframetrics*

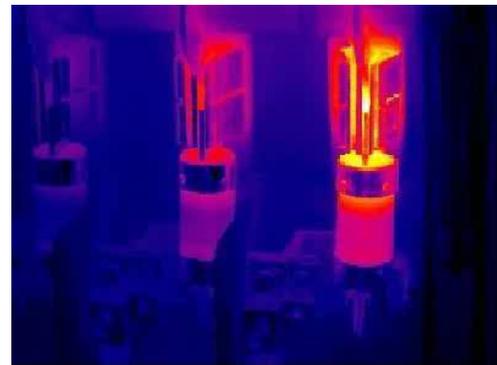
Overheated fuse. Could be caused by a poor connection or the fuse failure. *Image courtesy of the Academy of Infrared Thermography.*

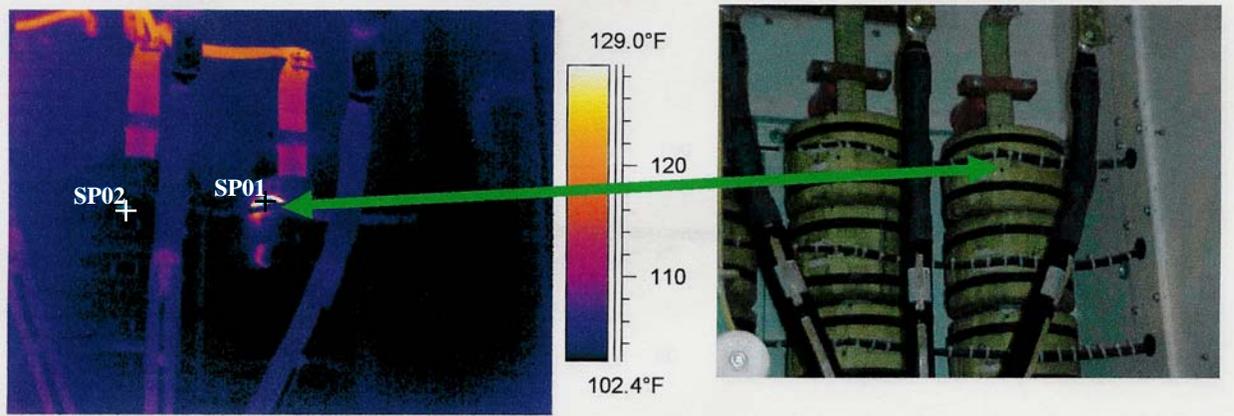
Anomaly 1. Hot “A” phase CT connection

Anomaly on a hot “A” phase CT connection. The arrow indicates the same spot on both images for reference. These images were obtained from an MWD infrared inspection report. The temperature scale between the images is set by the report writer and does not represent the full range of temperatures in the infrared image.

The first anomaly was found in the main connection panel for one of the pump motors. An infrared camera was used to inspect the panel. The anomaly, labeled as SP01, can be seen in the figure above. It was identified by comparing the two pieces of similar equipment at the same approximate location (SP01 and SP02 in the figure). The temperature at SP01 is 161.9°F and the temperature at SP02 is 102.3°F (differential of 59.6°F). The temperature differential was significant enough to warrant a recommendation of “Should be repaired as soon as possible.” In a priority scale of A-D where priority A warrants immediate repairs, this is a priority B.

According to Mr. Putnam, if this CT connection were to fail the motor would continue to be operational. However, it would have to be operated manually without the variable frequency drive. Since the problem was identified before any damage occurred, the CT connection can be cleaned and retested when the motor is out of scheduled operation (during the off-season) and probably will not need to be replaced.

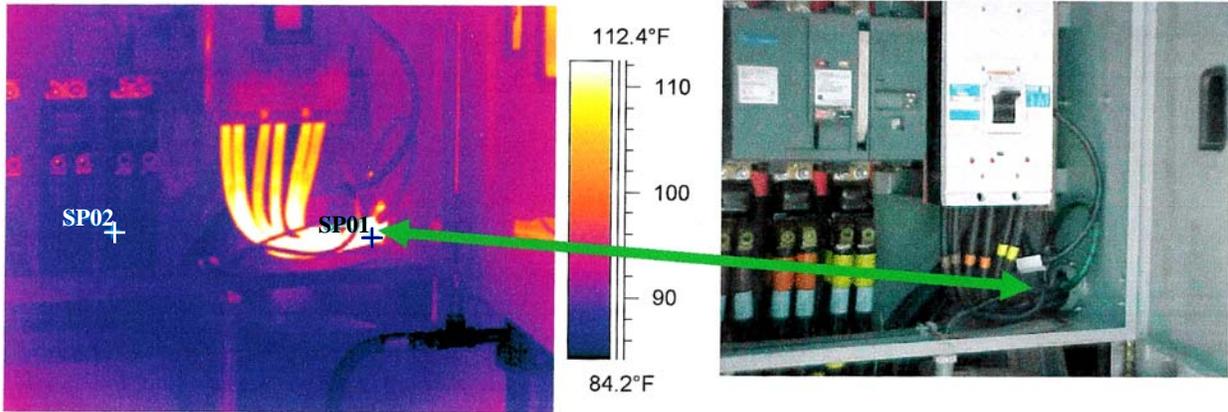
Anomaly 2. Possibly undersized cables to load bank.

The second anomaly was found during an inspection of the main breaker panel for a stand-by generator. The anomaly can be seen in the figure below. The cables entering the main

Possibly undersized cables in a main breaker panel. The arrow indicates the same spot on both images for reference. These images were obtained from an MWD infrared inspection report. The temperature scale between the images is set by the report writer and does not represent the full range of temperatures in the infrared image.

breaker panel are significantly hotter than the rest of the panel. In this case the investigator did not have similar equipment with which to compare the anomaly. Instead, the anomaly was compared to a spot in the panel. In this case, as in many others, it is difficult to determine if the heat generated in the cables is normal under the load. The temperature of SP01 was 141.3°F and SP02 was 87.2°F (differential of 54.1°F).

Because these cables are on an emergency stand-by generator, the problem may never escalate because the generator may never be used. However, if it is necessary to use the

generator and the cables fail, the result would be catastrophic. All equipment using this generator would also fail. Further damage, besides the cables melting, would be likely to occur. Fire or excessive heat could damage much of the equipment in the main breaker panel, as well as creating a risk of human injury.

Nevertheless, the experienced investigator set a repair priority of B (Should be repaired as soon as possible), with a recommendation that the cable sizes be verified for the load requirement and replaced if necessary.

Because of preventative maintenance, the cables will be further inspected and replaced if necessary with no downtime to the facility and without replacing any other equipment in the main panel.

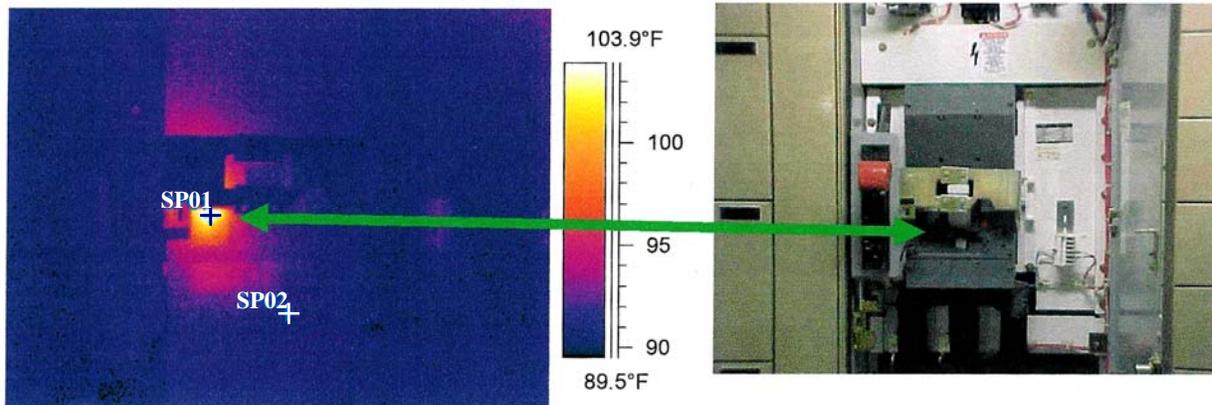
Anomaly 3. Warm “A” phase breaker contact.

The figure below shows a breaker contact that was warmer than the surrounding equipment. SP01 had a temperature of 104.3°F

Warm breaker connection. The arrow indicates the same spot on both images for reference. These images were obtained from an MWD infrared inspection report. The temperature scale between the images is set by the report writer and does not represent the full range of temperatures in the infrared image.

and SP02 had a temperature of 91.7°F (differential of 12.6°F). In this case the breaker contact was faulty and warranted replacement of the breaker. Because of the relatively small temperature differential, the investigator gave a repair priority of C (Should be attended to at first priority).

If this problem were not repaired, over time the connection would continue to increase in temperature, possibly damaging additional equipment and hampering the effectiveness of the breaker itself. Instead, the breaker can be replaced at the facility's scheduled downtime without difficulty.

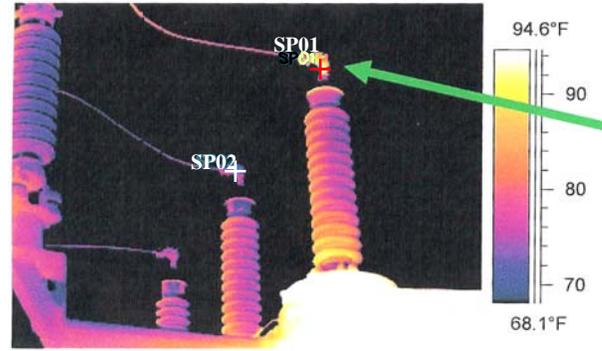
Anomaly 4. Warm "A" phase cable-to-bushing connection.

The final anomaly at the facility was on one of the facility's transformers. This is not a typical piece of equipment for a water agency to maintain, but it is interesting how a problem that could potentially be very expensive if allowed to develop could be prevented with early detection and minor cleaning. Most heat anomalies that occur at electrical connections can be solved with very minor, inexpensive maintenance. However, if they are allowed to run their course, the damage could be enormous.

In this case, the connection in the figure at SP01 had a temperature of 93.2°F and the temperature at an identical connection at SP02 was 72.2°F (differential of 21°F). Mr. Putnam estimated that catastrophic damage probably would not have occurred for another 10-15 years because of this problem. The investigator gave a repair priority of C (Should be attended to at first priority), with the recommendation to clean the connection and retest.

If the problem was not repaired, it is possible that the entire transformer could have been damaged, causing tens of thousands of dollars in damage just because of a faulty connection that needed cleaning.

Warm "A" phase cable-to-bushing connection on main transformer. This image was obtained from an MWD infrared inspection report. The temperature scale is set by the report writer and does not represent the full range of temperatures in the infrared image.
