Center Pivot Design for Effluent Irrigation of Agricultural Forage Crops

Franklin Gaudi¹, Daniel Howes², Donald Ton³

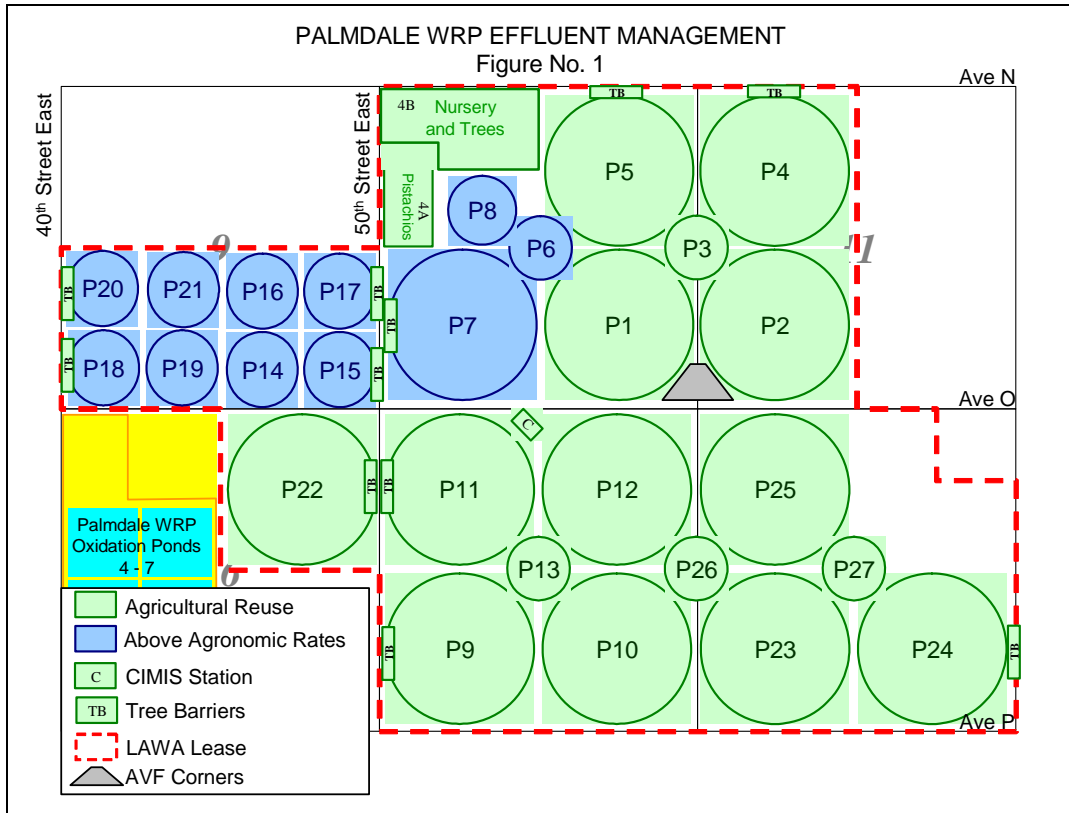
Figure 1. Palmdale center pivot layout

To achieve these objectives, the Palmdale EMS presently utilizes 27 center pivots providing water to over 2,000 acres of forage crops, a tree nursery, a pistachio orchard, and 11 tree barriers. A general map of the Palmdale EMS is presented in **Figure 1**.

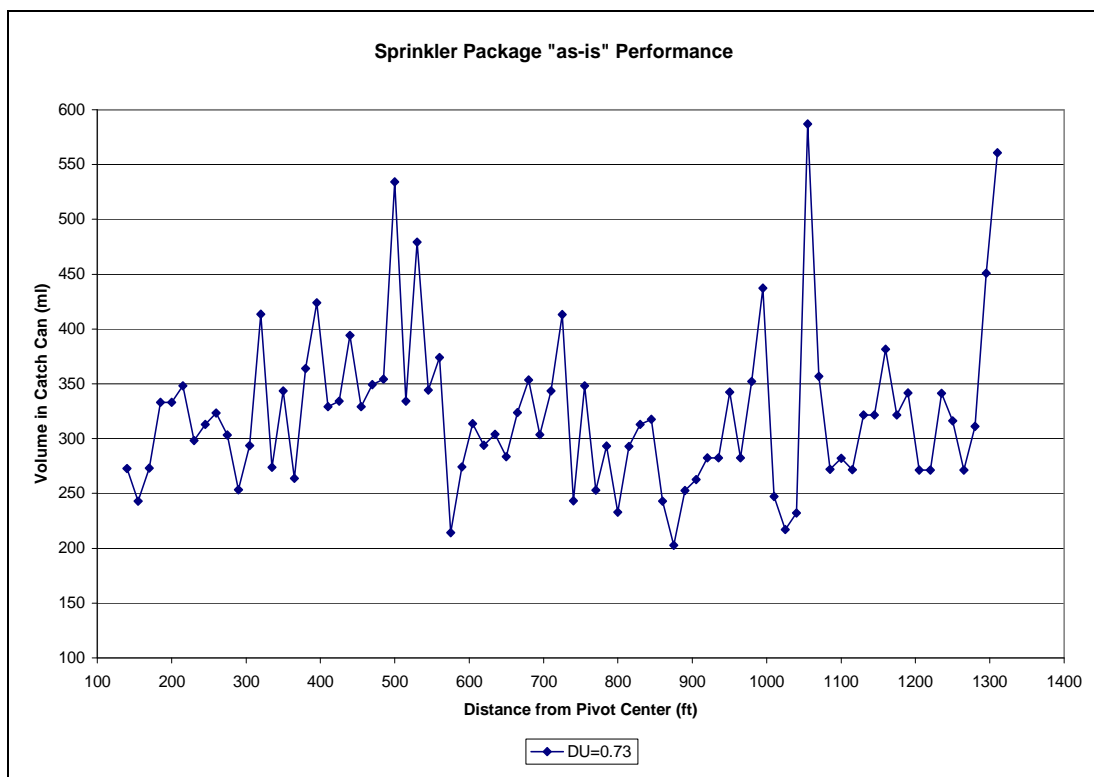
Figure 3. Catch can values along the length of the machine (non-weighted)

Prior to making any modifications to the “representative” center pivot a DU evaluation was conducted to verify the pivot package design in an “as-is” state. This provided a good estimate for the DU values that could be expected within the EMS. The resulting DU was 0.73. **Figure 3** illustrates the catch can volumes in relationship to the pivot center.

The pivot sprinkler package designed DU is 0.90. To achieve this goal modifications to the center pivot and sprinklers needed to be made. The improvements were selected to decrease the variations between catch cans.

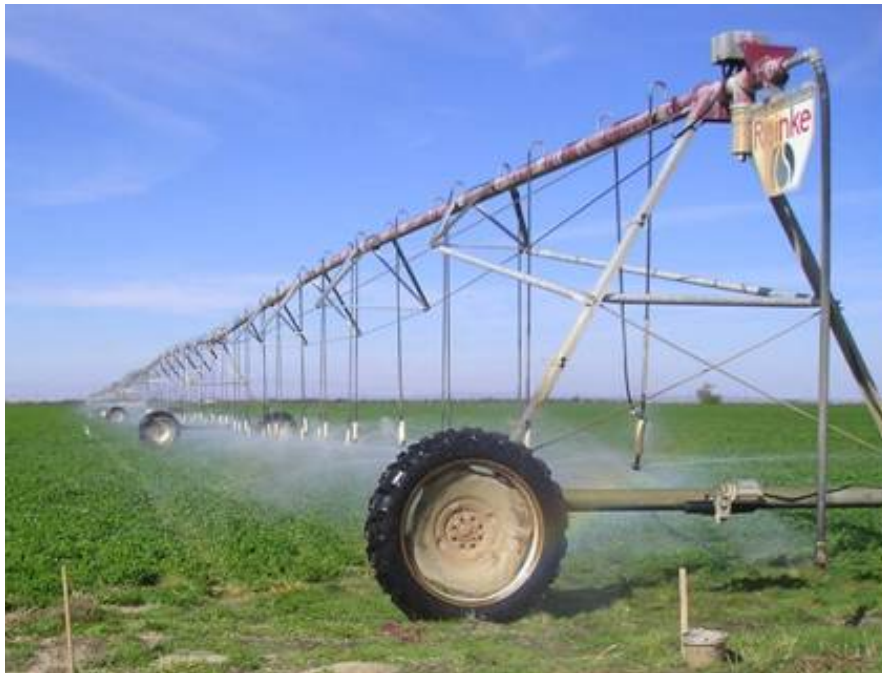
Figure 4. Original sprinkler heights – average 3.5 feet

Sprinkler spacing for center pivots are designed for a certain amount of overlap. This overlap ensures the proper distribution uniformity during irrigation. In previous years, the District had focused on limiting and/or preventing drift from the pivots from leaving the field by lowering many of the sprinklers (typically near the end of the machine) to an elevation just above the canopy height just before harvest (**Figure 4**). Unfortunately, this process negatively affected the DU of the pivot.

The manufacturer of the sprinklers, Nelson Irrigation, was consulted to verify the correct mounting height for the sprinklers. The original pivot package for Pivot 2 utilized the R3000 rotator with green plates. This plate is designed to operate in a pressure range between 20-50 psi and at a height of 6 to 9 feet (Nelson Irrigation Corporation, 2005).

The sprinkler heights for the initial DU test (before modifications) ranged between 30 inches and 48 inches and had an average sprinkler height of approximately 42 inches. This limited the throw diameter and ultimately the overlapping of each sprinkler. To correct this, the sprinklers were modified so the average height was 66 inches (**Figure 5**); half at 60 inches and half at 72 inches. Prior to raising the height of the sprinklers, however, the District had mitigated drift concerns through chlorination of the secondary treated wastewater.

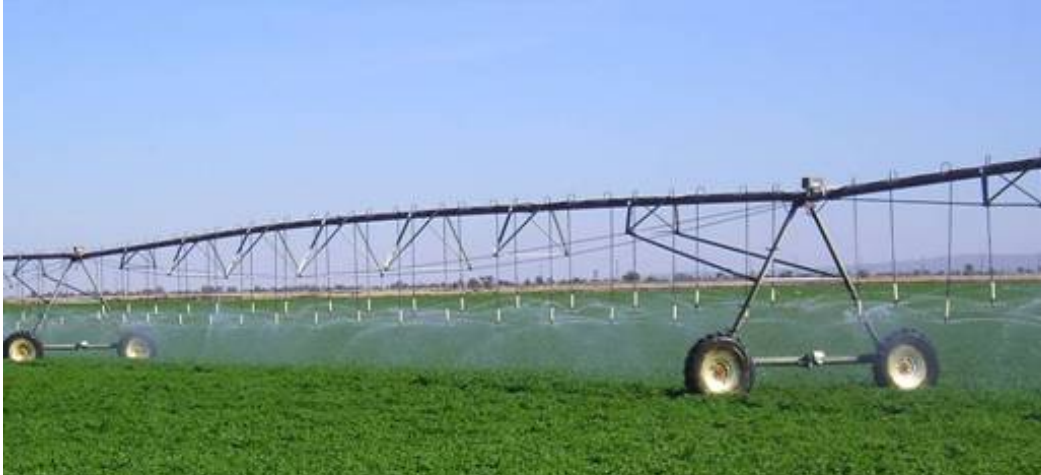
Figure 5. New sprinkler heights – average 5.5 feet

The R3000 rotator sprinklers were not placed as high as the manufacturer recommended because the pivot was operating at about 40 psi and wind drift is still a bit of a concern – even though the District now uses secondary treated chlorinated wastewater. In addition, maintenance of the sprinkler is more difficult at a high setting; this is discussed further in a later section.

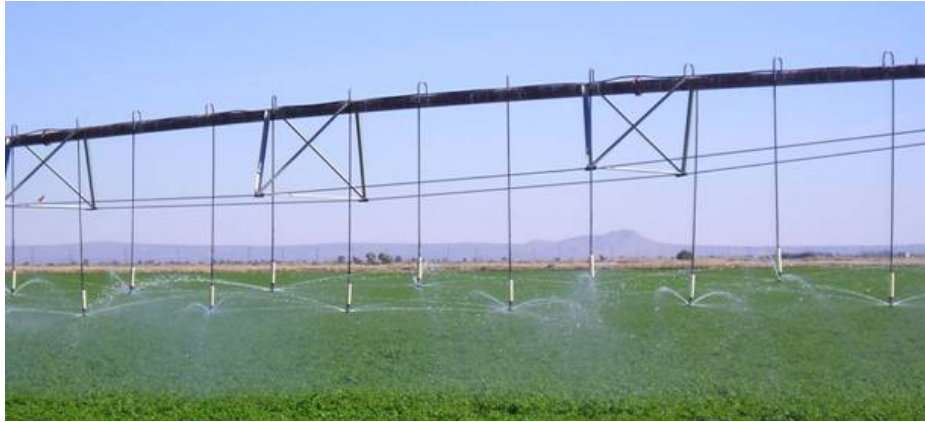
Figure 7. Staggered sprinklers to minimize spray pattern collisions and swinging

In order to minimize stream collisions, drop hose heights can be staggered. For example, one sprinkler is set at 5 feet and the two adjacent sprinklers are set at 6 feet. This amount of stagger also prevents the water streams from colliding into the sprinkler weight – causing the sprinklers to swing while operating.

As part of the modifications every other sprinkler was staggered vertically by one foot to minimize the spray patterns hitting each other and to minimize sprinkler swinging (**Figure 7**).

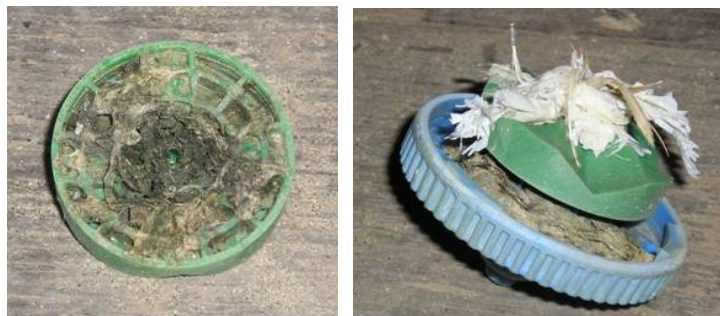
Figure 8. Sprinklers with trash on rotator plates

Partial nozzle plugging and debris buildup on sprinkler nozzle plates was evident during the initial evaluation. Plastics, feathers, and algae in the irrigation water were the primary cause of this problem. Debris buildup on and under the rotator plate and nozzle plugging (even partial plugging) can have a significant negative impact on the distribution uniformity of the irrigation system. The debris impacts the nozzle spray pattern and prevents proper spinning of the rotator plates. This, in the end, results in poor application coverage. **Figure 8** illustrates an example with a rather heavy debris load.

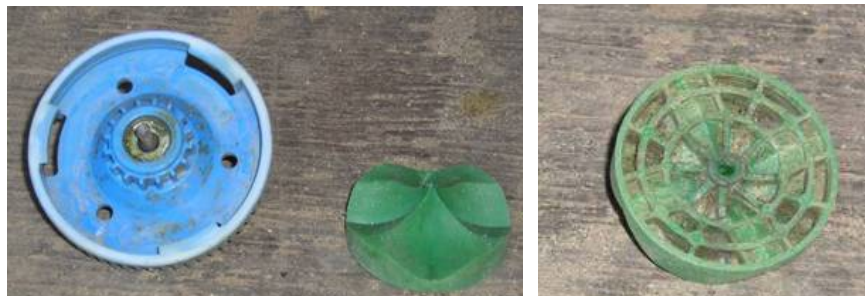
Figure 9. Clean rotators and rotator plates

As part of the modifications, each of the rotator plates was removed from the rotators and thoroughly cleaned (**Figure 9**).

Nearly all of the sprinklers had algae or debris buildup between the rotator plate and rotator. Inadequate filtration was the cause of these issues. Therefore, the District decreased the maintenance interval between servicing and cleaning the sprinklers and filters.

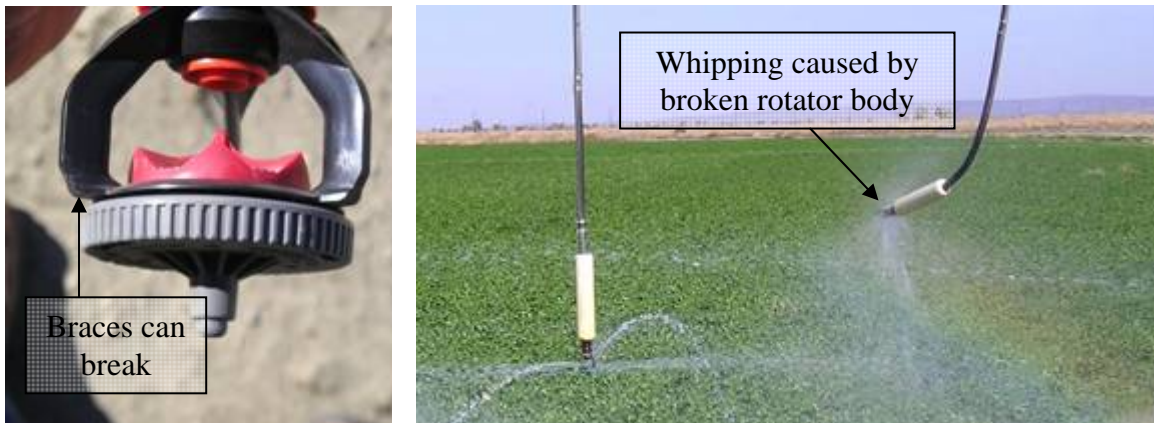
Figure 10. Non-functioning sprinkler because of broken rotator body

Approximately 25 sprinkler bodies had to be replaced because they were either cracked, broken, or bent. The rotator body that is utilized at the Palmdale WRP is the “Trash-Buster”. The open-body architecture allows for debris to pass through more easily, alleviating buildup of material on the plate and body of the sprinkler. Replacing cracked and broken rotator bodies was also part of the increased maintenance program.

A majority of the bad rotator bodies had cracked braces that support the rotator and rotator plate. This prevents the water stream from striking the rotator plate correctly. This in turn can prevent the sprinkler from operating properly, if at all (as shown in **Figure 10**).

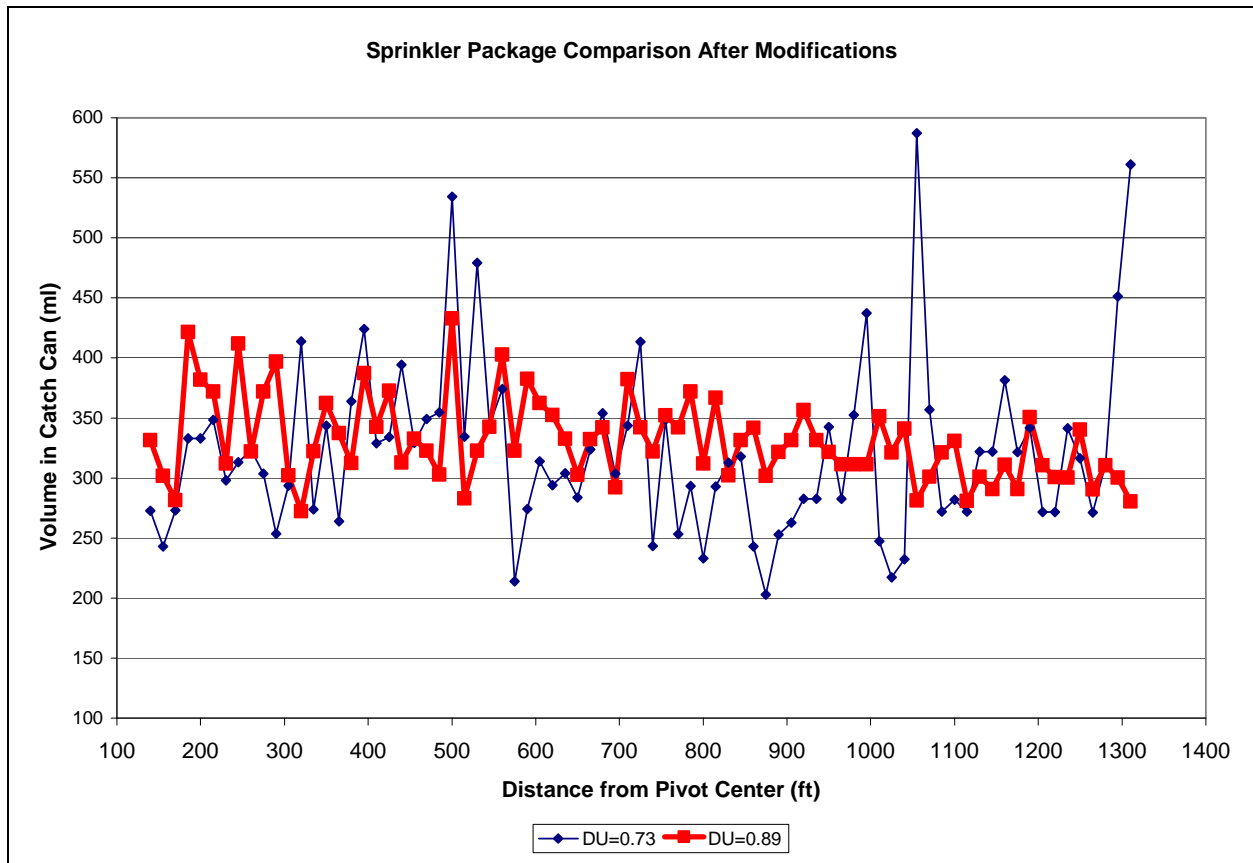
Figure 11. Catch can volumes from pivot center to edge of field (non-weighted)

A comparison of catch can volumes (non-weighted) before and after modifications is shown in Figure 11. The results were:

The initial DU = 0.73
DU with improvements = 0.89

Although there appears only to be some improvement between evaluations, the difference in DU is linked to the points on the right half of the figure. These points, when weighted, improve the DU because they represent a large portion of the field. For this reason, the modifications proved to be very effective at improving the DU for an individual pivot and ensuring that a majority of the pivot is representative of the entire field.

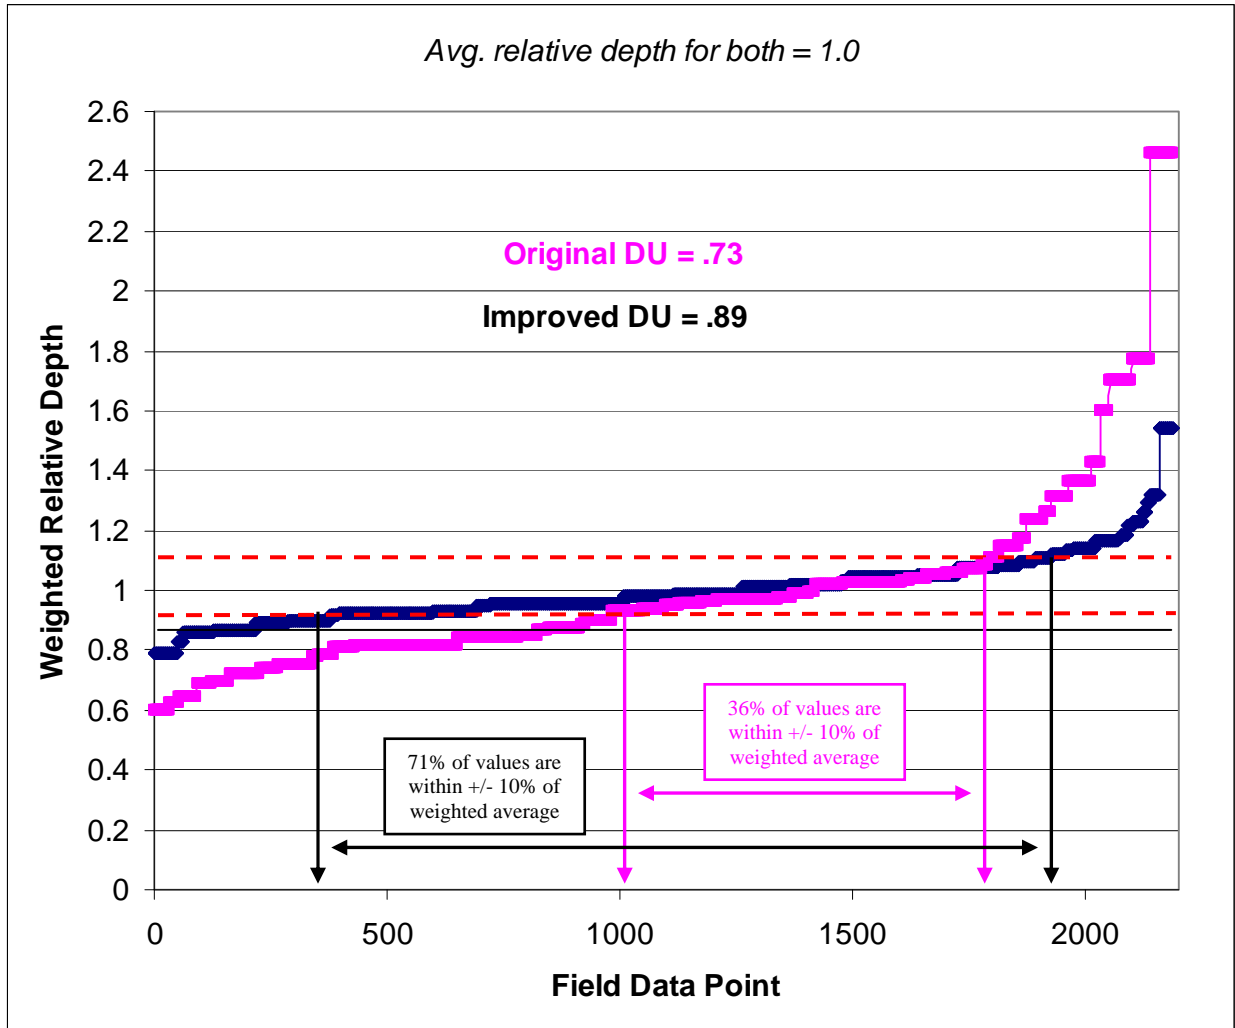
Figure 12. Improved performance in DU

Figure 12 illustrates that the number of points that fall within +/- 10% of the weighted average is greatly improved as the DU approaches 1.0. This equates to:

1. improved application uniformity
2. increased water efficiency (assuming good irrigation scheduling) minimizing deep percolation
3. simpler irrigation scheduling
4. an increase in representative sampling locations throughout the pivot
5. improved soil sensor reliability because its location is most likely more representative

Figure 12 demonstrates that with the original package, approximately 36% of the field is representative of the entire field. However, increasing the DU from 0.73 to 0.89 improves the representative segment of the field to about 71%. This simplifies management and operation by improving the likelihood that a plant tissue sample or soil moisture sensor station is within a representative portion of the field.

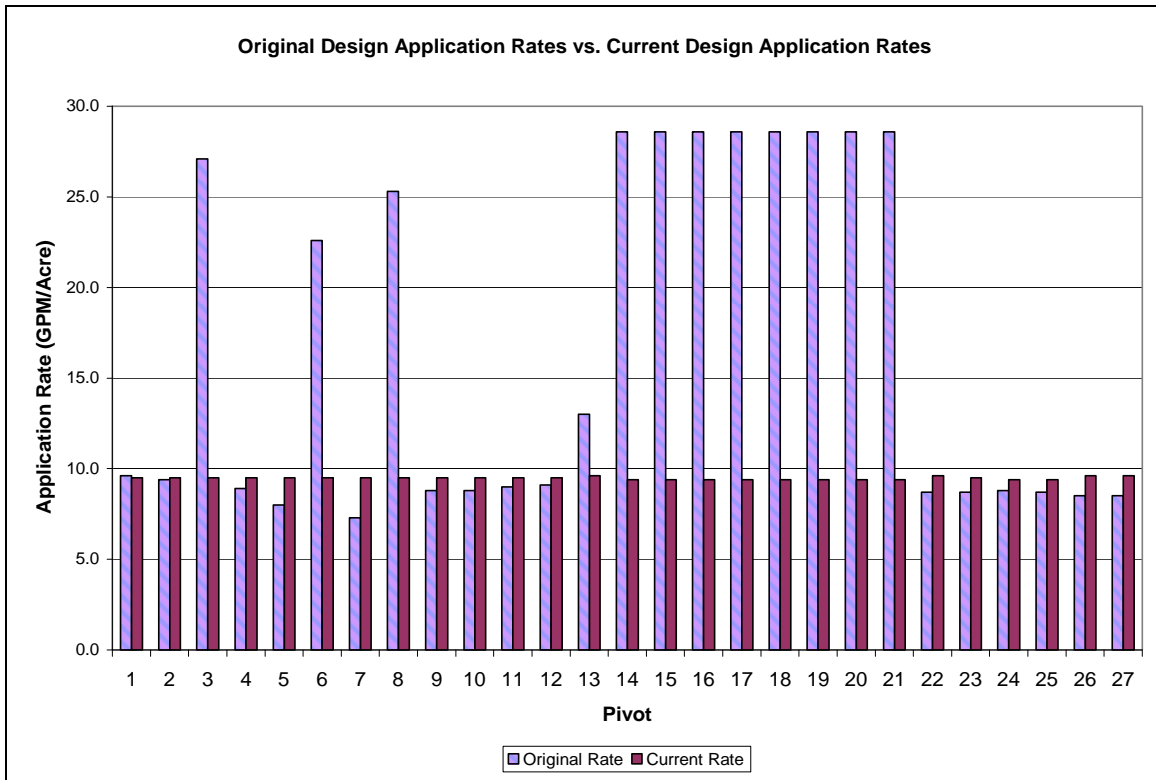
Figure 13. Original design precipitation rates vs. current design precipitation rates

An analysis of the center pivots' design flow rates compared to the peak evapotranspiration (ET) requirement for alfalfa in the Antelope Valley indicated that most of the large pivots did not have enough flow rate capacity. On the other hand, the small pivots had application rates nearly three times what is required, making irrigation scheduling more difficult. The peak evapotranspiration of alfalfa irrigated using center pivots will vary depending on the speed at which the center pivot moves.

For example, running a pivot on a 14-hour rotation will lead to higher evaporation because the plant surface is wetted more frequently than when using a 48-hour rotation. The estimated peak evapotranspiration rate of alfalfa in July in Palmdale, assuming a 24-hour rotation, is about 0.4 inches/day or 7.5 GPM/Acre (940 GPM/125 Acres). After incorporating a minimum distribution uniformity of 0.80, the required system flow rate is 0.5 inches/day or 9.4 GPM/Acre (1200 GPM/125 Acres) with no under-irrigation.

To simplify irrigation management all pivot packages were designed with the same 9.5 GPM/Acre requirement. That way, the same depth is applied per hour, regardless of what machine is operating. **Figure 13** shows that the original application flows varied from 7.3 to 27.3 GPM/Acre and the current application flow range varies from 9.4 to 9.6 GPM/Acre. In most cases the District had to re-nozzle each individual pivot. However, making these modifications greatly simplified the operation and irrigation scheduling for each center pivot.

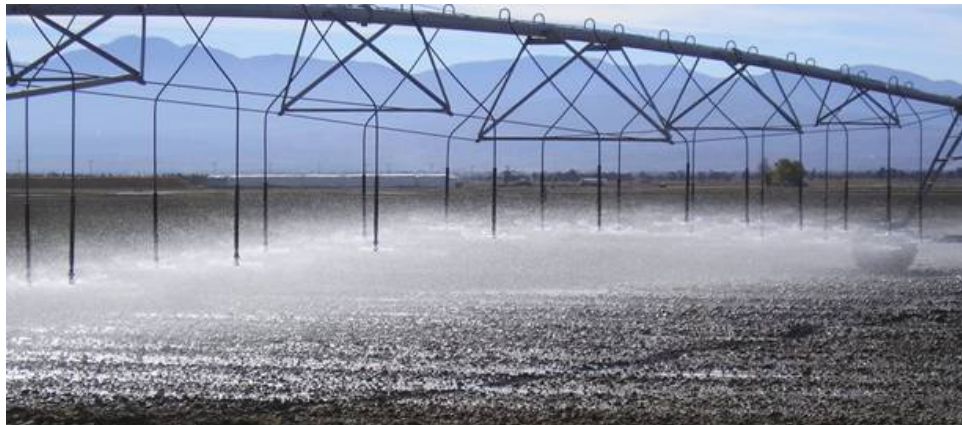
Figure 14. Drops strung over truss rods to increase the wetted area

In areas where the soil is somewhat heavier (sandy loam) the drops were strung over the truss rods to increase the wetted area (reducing the instantaneous application rates) without replacing the nozzles (**Figure 14**).

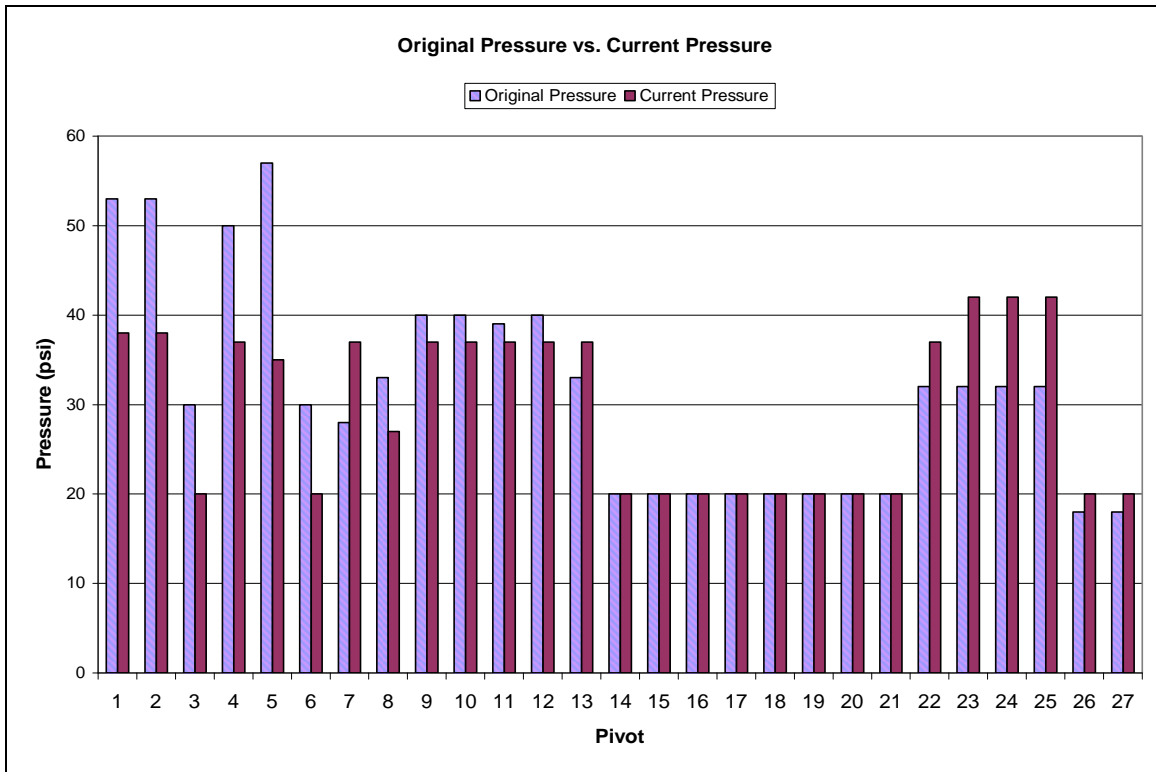
Figure 15. Original pressure vs. current pressure requirements

To reduce under-pressurizations the pivot sprinkler packages were reduced from about 50 psi to about 35 psi. This has several benefits, including larger nozzles that will pass debris more easily and less stream break-up due to increased droplet size – improving the sprinklers’ wind fighting abilities to maintain a reasonable DU even during high wind events.

Figure 15 illustrates how the pressure requirements were adjusted. Pivots 22-25 needed increased pressure to compensate for the increase in flow rate and the addition of end guns.

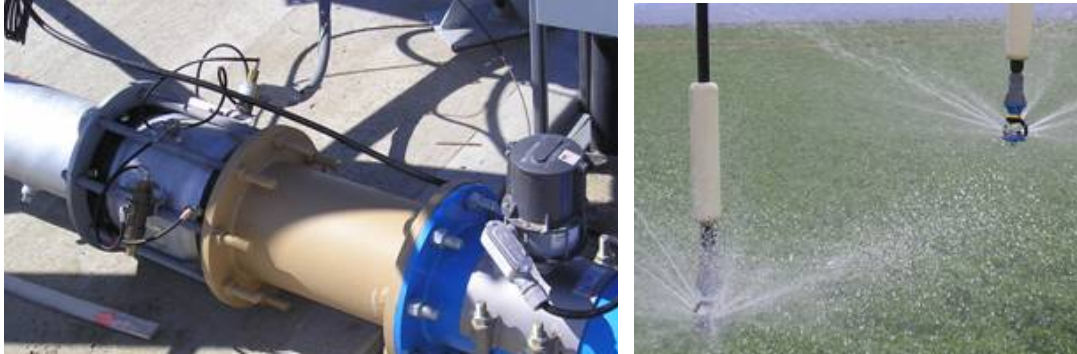
Figure 16. In-line pressure regulator (left) and individual pressure regulators (right)

All mini pivots (shorter than 700 ft in length) have individual sprinkler regulators and all large pivots (greater than 770 ft in length) have one in-line pivot regulator. The decision to use two types of pressure regulation was linked to economics. **Figure 16** shows both types of regulators. Both options provided adequate results and helped stabilize the flows onto each field.

To overcome the slight reduction in DU caused by the lower sprinkler heights the rotator plates were changed to brown (see **Figure 16**). The brown rotor plates replaced the green plates for a number of reasons:

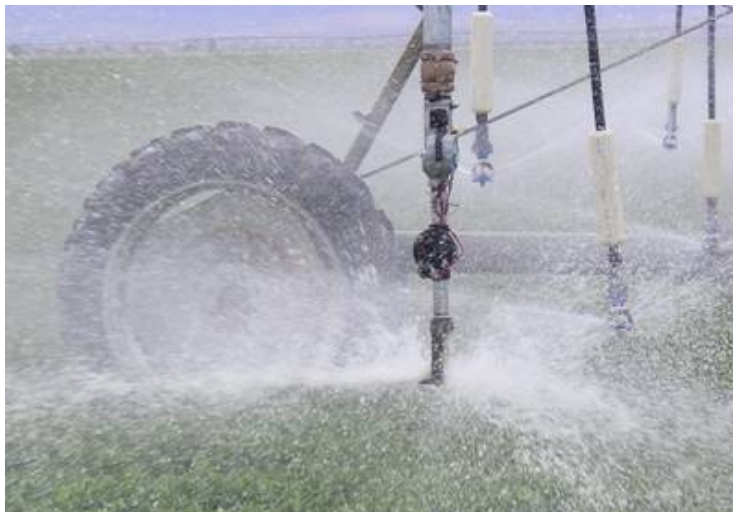
Figure 17. Automatic center pivot end flush

In addition, a flush valve with a battery-operated automatic timer was installed at the end of most machines to flush large debris from the pivot twice daily. Because the process is automatic the system is flushed during operation and not just at startup, which was the previous standard protocol (**Figure 17**).
